Test Report

Report No.: WP-20096849-JC-01En

Sample Name : steel pedestal

1. Test Item: Neutral salt spray test (NSS)+Load bearing experiment

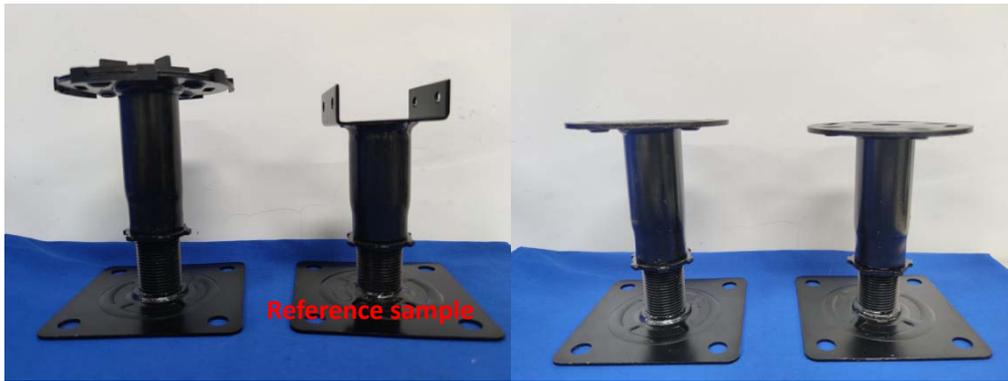
Figure 1Pre test photos

Figure2Pre test photos

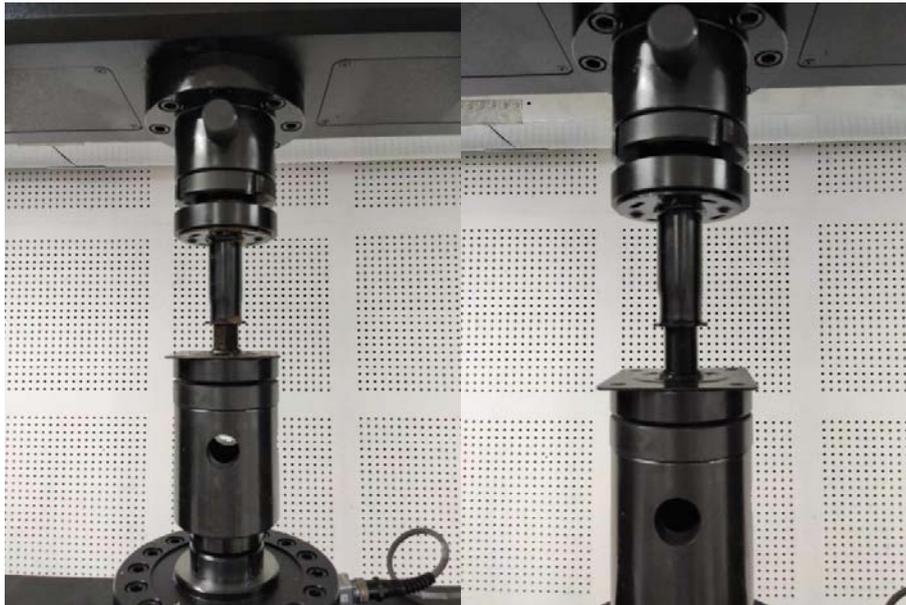
Figure3 Photos in the test

Figure4Photos in the test

Sample NO.	Sample type	Test items	Test Result(s)
200907365-2	Primitive sample-1#	Load bearing experiment	113.2kN
	Primitive sample-2#		96.9 kN
	After 168 h of neutral salt spray test -3#		110.8 kN
	After 168 h of neutral salt spray test -4#		112.2 kN

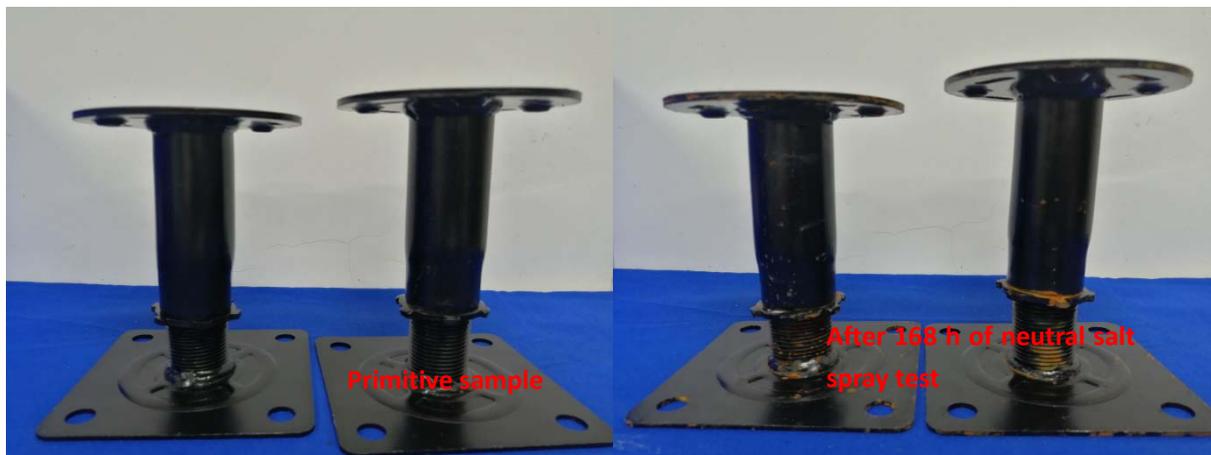
Figure5 Photos after test

Figure6Photos after test
